Custom Mortar Matching Report

Project # USHG303

Site: Emily Dickinson Homestead, Amherst, Massachusetts

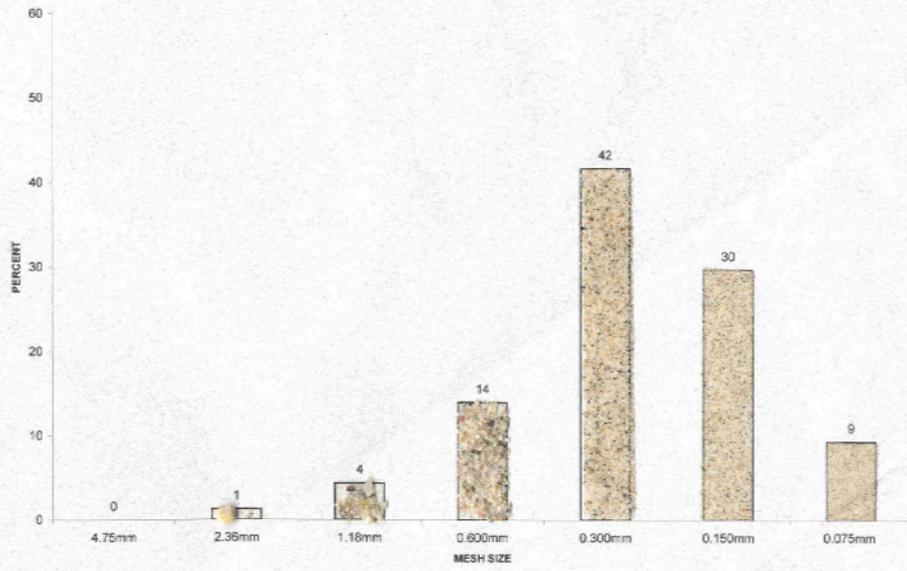
USHG # 303 - Sacco & McKinney Architects

The sand grain distribution chart illustrating the sand isolated from your sample is attached.

As indicated in the chart above, the majority of the aggregate found in the sample is primarily 0.300mm making up 42% of the total aggregate used. The material is well distributed throughout the mesh sizes. The material is classified as a medium sized aggregate. The aggregate appears to be sub-angular in shape. This suggests the aggregate was obtained locally, likely from a river or lake. Under magnification the majority of the aggregate is transparent in color with an assortment of gray and white particles scattered throughout the material. The binder is white.
